NASA/TM-2014-218406

Investigation of Spiral Bevel Gear Condition Indicator Validation Via AC–29–2C Using Fielded Rotorcraft HUMS Data

Paula J. Dempsey Glenn Research Center, Cleveland, Ohio

Daniel R. Wade U.S. Army Aviation Engineering Directorate, Redstone Arsenal, Alabama

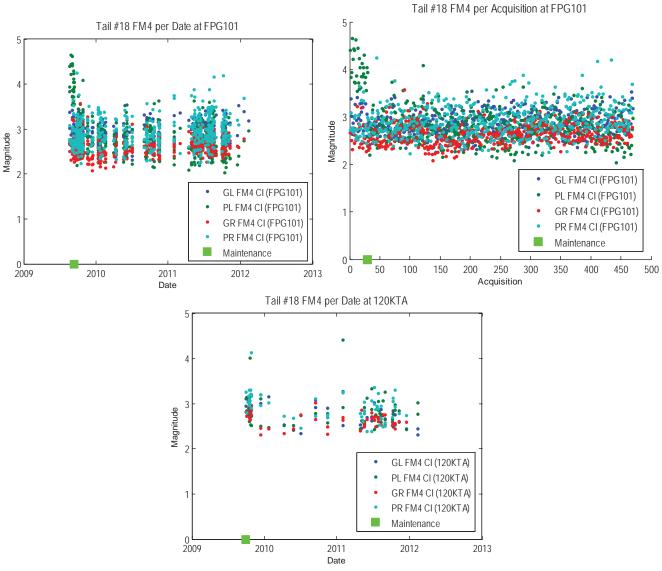
Figure 4.—Tail Number 18 Plots of FM4 per Date, Acquisition and Regime

Per Table 3, severe spalling was observed on the left pinion teeth prior to gearbox replacement. FM4, SI3, DiffDA1 and DP2P CI values for the left pinion all responded prior to replacement. All four exceeded threshold limits set per historical fleet data. FM4 exceeded 4.5, SI1 and SI3 exceeded 6, DiffDA1 exceeded 15 and DP2P exceeded 100 prior to replacement for the FPG regime. No120KTA regime data was available prior to replacement.

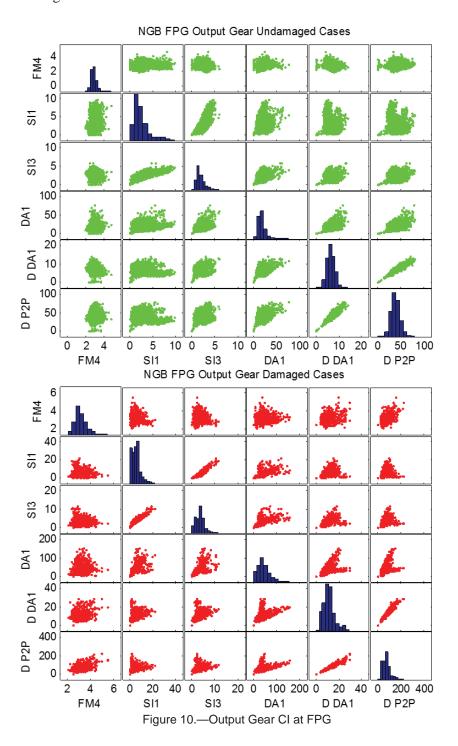
Figure 10, Figure C.1.1 in Appendix C, contains histograms and gear CI data at the FPG regime using data from helicopters with undamaged components and helicopters with damaged components. The damaged component data set contains CI data before replacement only. The top plot, in green, is the data from the 20 tails without damage. The bottom plot, in red, is the plot of the tails with gear set damage. The histograms are shown in blue. The matrix of plots enables linear relationships between the CIs to be seen. These plots also provide a qualitative representation of the differences in CI values between the damaged and undamaged cases.

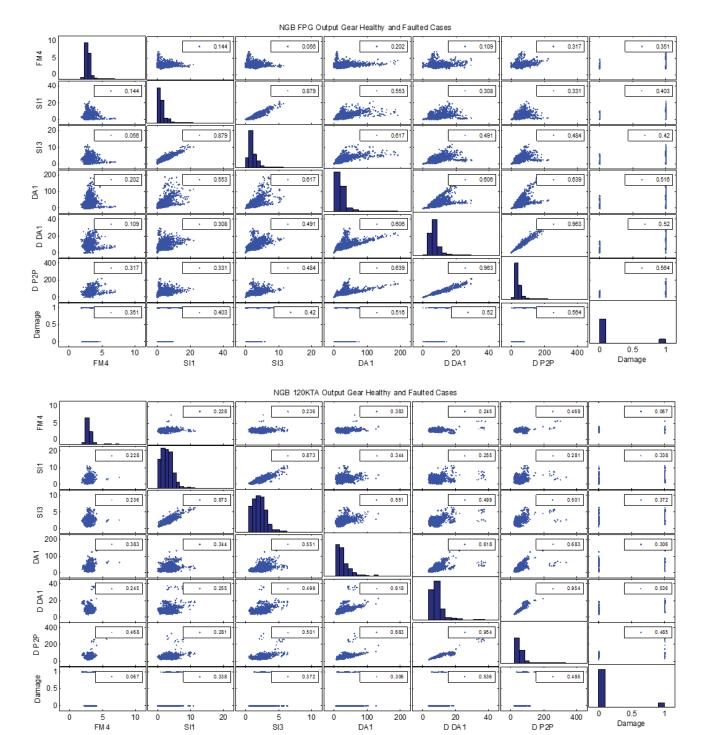
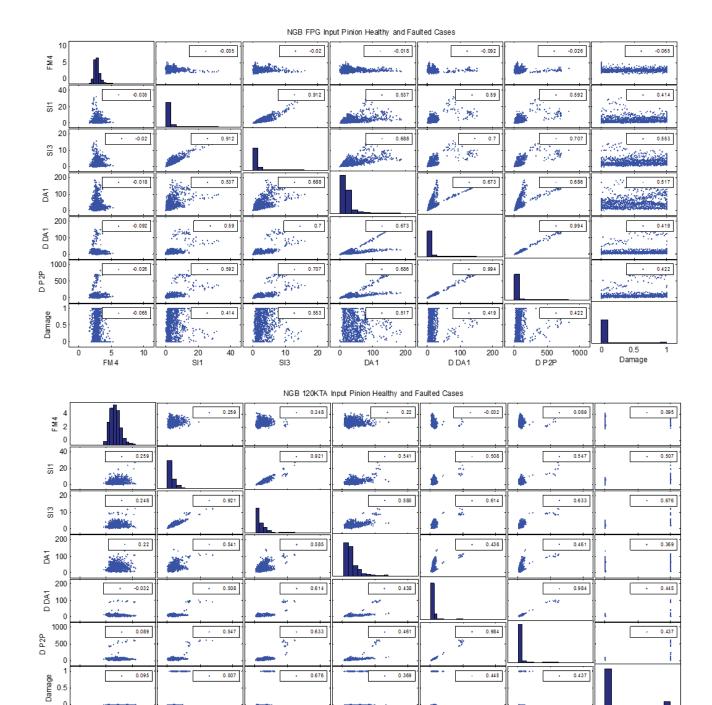
Figure 12.—Input Pinion CI Correlation Matrix

Figure 11 and Figure 12 provide plots and correlation coefficient for the combined undamaged and damaged tails at the two regimes. The strong linear relationship seen between SI1 and SI3 and between DiffDA1 and DP2P in Figure 10, can also be seen and quantified in these plots with correlation coefficient values of 0.9 or greater. However, none of the correlation coefficient values between CIs and damage state exceeded 0.7. This is most likely due to the variance in the undamaged data set.

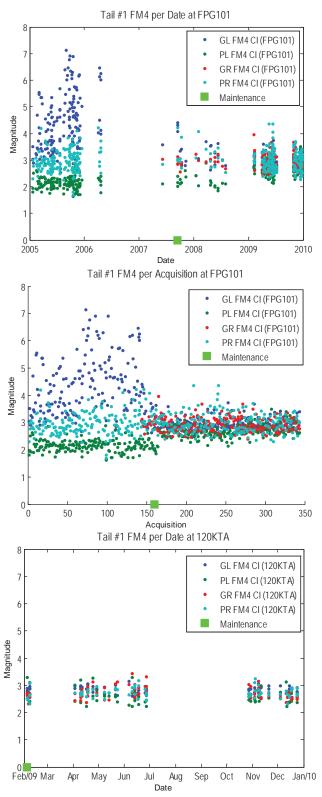
Figure A.1.1.—Tail Number 1 Plots of FM4 per Date, Acquisition and Regime

FM4 responded to damage for **four** tails: numbers 1, 7, 13 and 18.

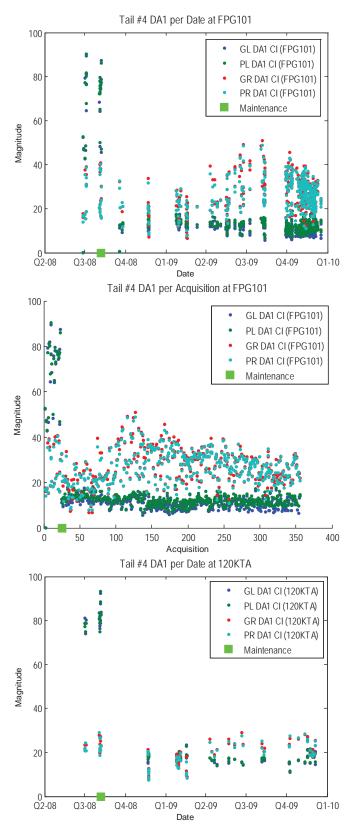
Figure A.4.2.—Tail Number 4 Plots of DA1 per Date, Acquisition and Regime

DA1 responded to damage for six tails: numbers 4, 13, 14, 15, 16 and 20.

- PL, PL*, GL and GL* responded to one tail (no. 4) with left pinion and output bearing damage and two tails (nos.14 and 16) with left gear and pinion damage and one tail (no. 4) with left pinion and output bearing damage.
- PL responded to one tail (no. 15) with left gear and pinion damage. This was the case of moderate wear to the gear and pinion teeth.
- PR and PR* responded to one tail (no. 13) with right pinion and gear damage. This was the case of the chipped gear tooth on the toe side.
- PR and GR responded to one tail (no. 20) with right gear and pinion damage.
- For several tails where the CI responded poorly, the CI value was monotonic.
- Since the FPG101 regime has a wide torque band, and this CI is known for its sensitivity to torque, this may be the cause of its poor performance.

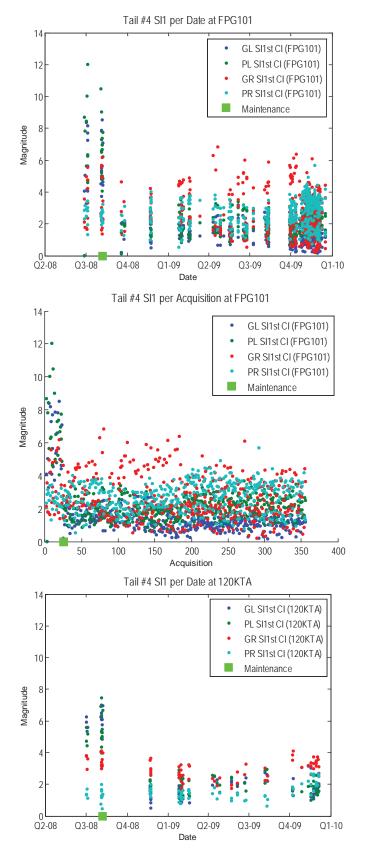
Figure A.4.3.—Tail Number 4 Plots of SI1 per Date, Acquisition and Regime

SI1 responded to damage for **10** tails: numbers 4, 5, 6, 8, 10, 13, 14, 15, 16, and 20.

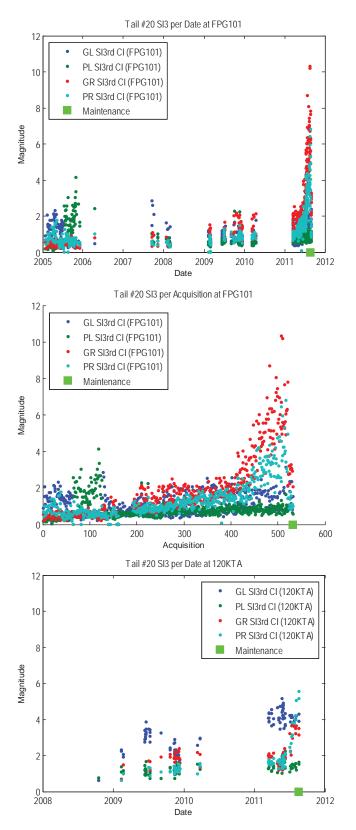
Figure A.20.4.—Tail Number 20 Plots of SI3 per Date, Acquisition and Regime

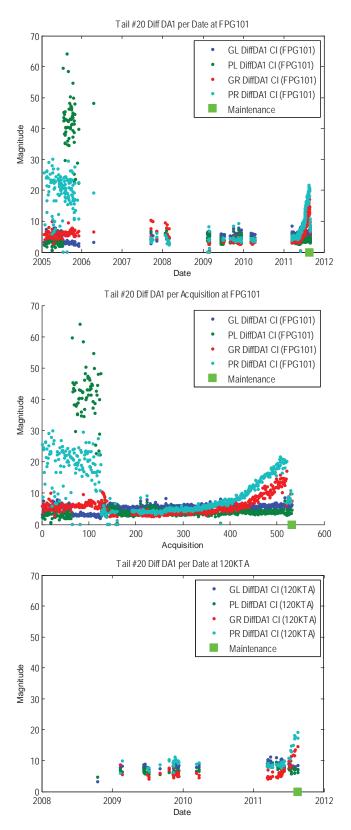
Figure A.20.5.—Tail Number 20 Plots of DiffDA1 per Date, Acquisition and Regime

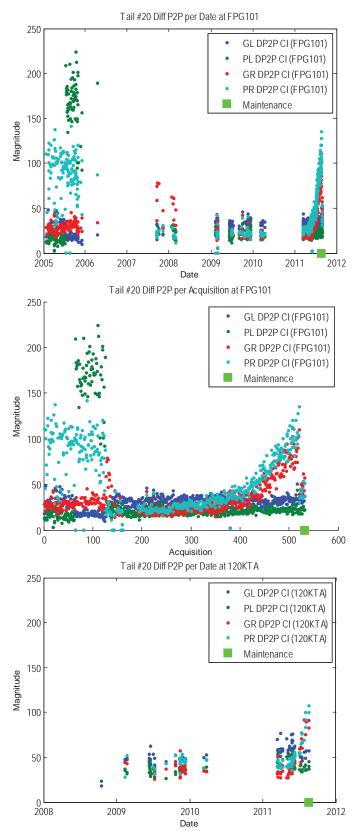
Figure A.20.6.—Tail Number 20 Plots of DP2P per Date, Acquisition and Regime

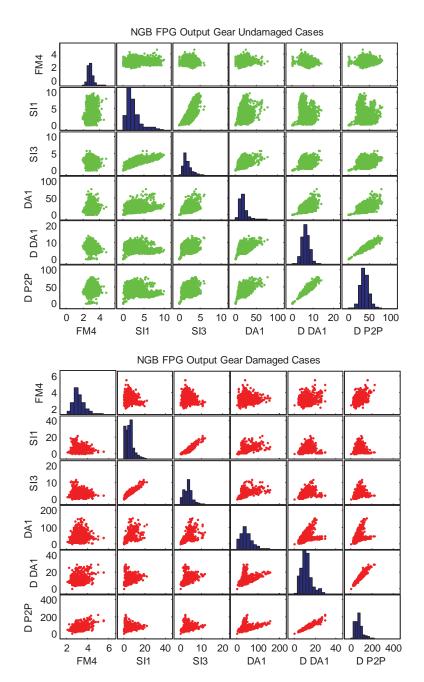
Figure C.1.1.—Output Gear CI Comparison for FPG Regime

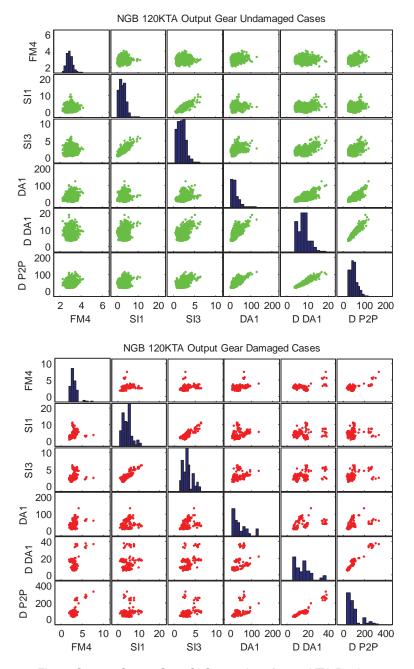
Figure C.1.2.—Output Gear CI Comparison for 120KTA Regime

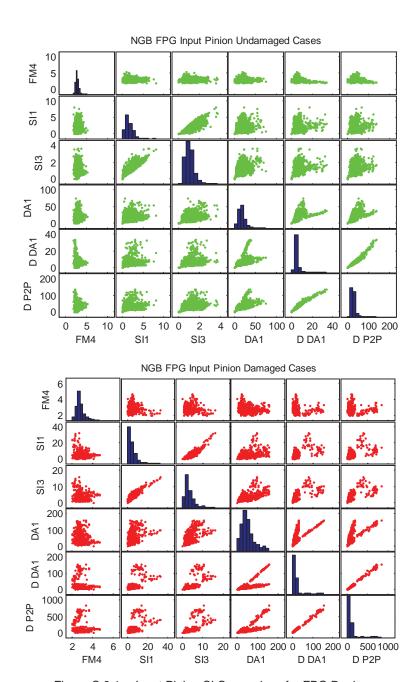
Figure C.2.1.—Input Pinion CI Comparison for FPG Regime

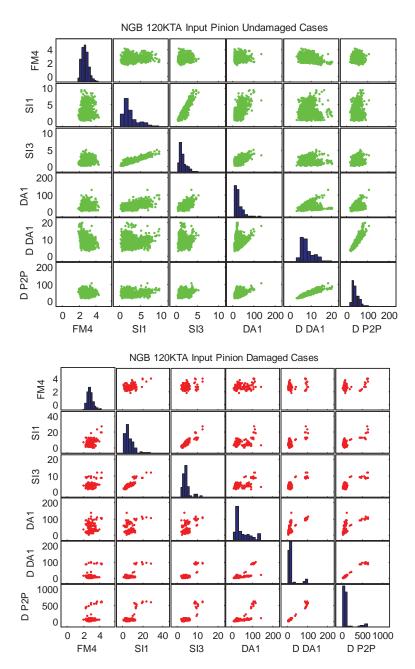
Figure C.2.2.—Input Pinion CI Comparison for 120KTA Regime
